Structural Audit Report
of
“K.G Mittal College, Malad (West) Mumbai

SEPTEMBER - 2020

**STRUCTWEL DESIGNERS &
CONSULTANTS PVT. LTD.**

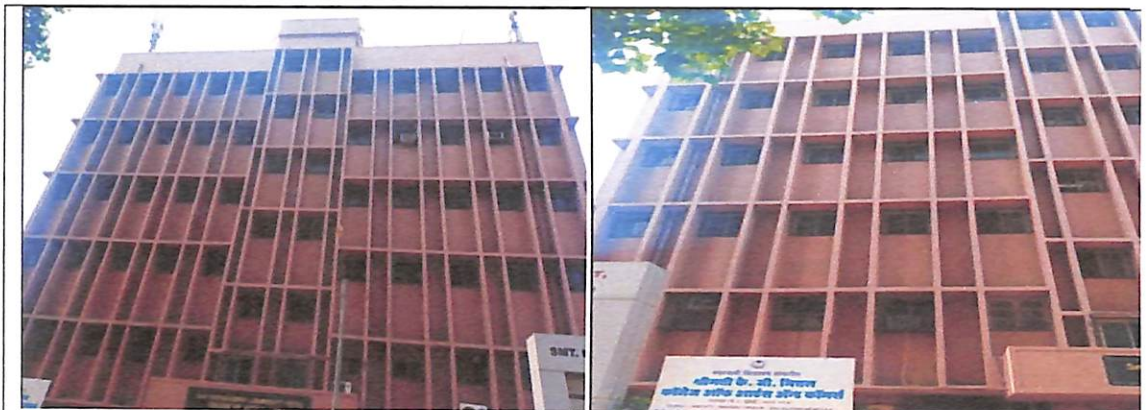
Location: – South Side elevation	
Distress: – No distress observed.

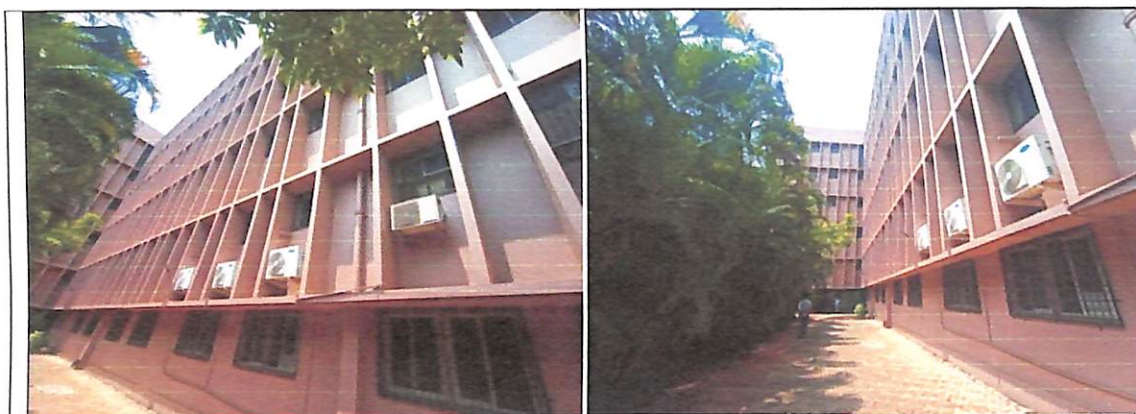
Location: – East Side elevation

Distress: – No distress observed.

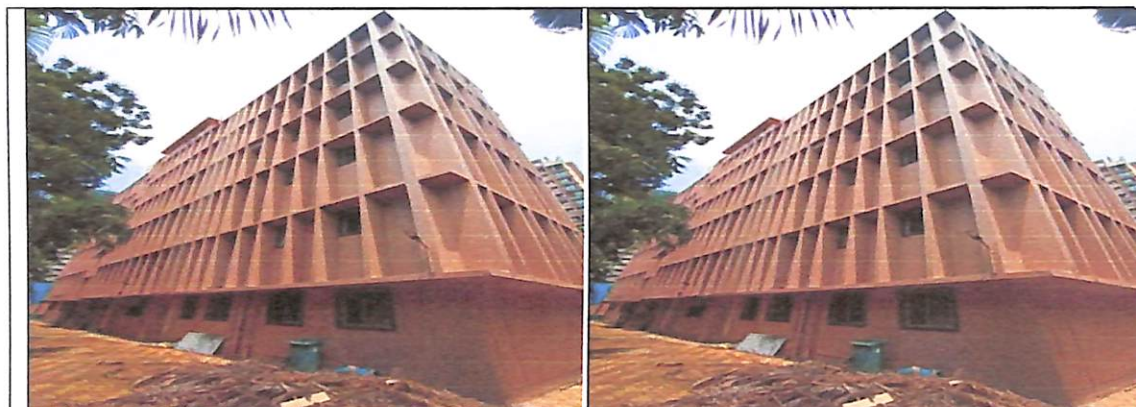
Location: – North Side Elevation

Distress: – No distress observed.

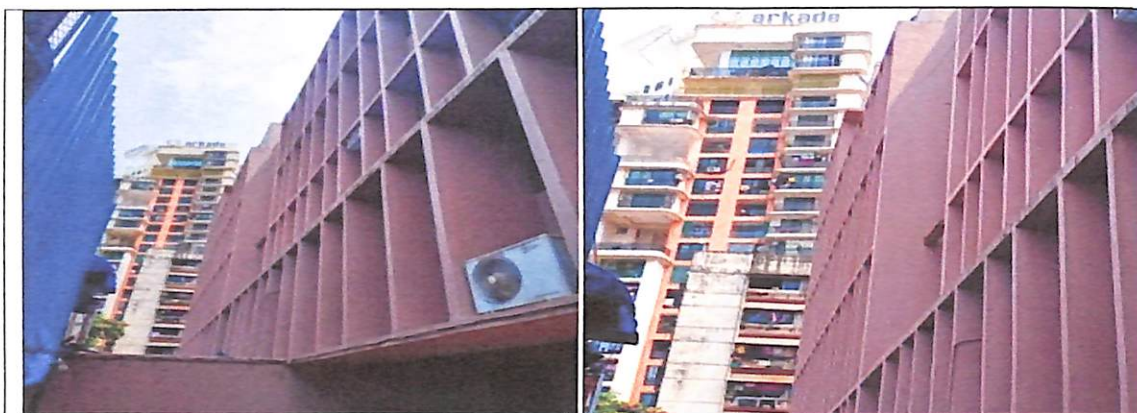
Location: – East Side Elevation

Distress: - No distress observed.

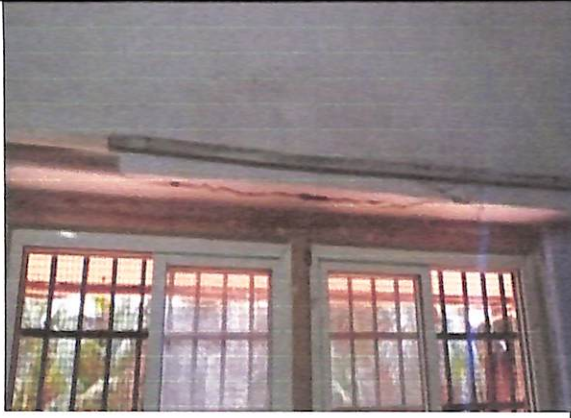
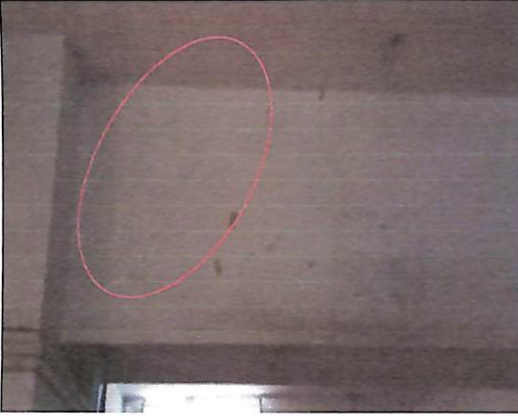
Location: – Auditorium Hall	
Distress: — A lintel crack is seen on the window. Also, a diagonal crack is seen in the beam.

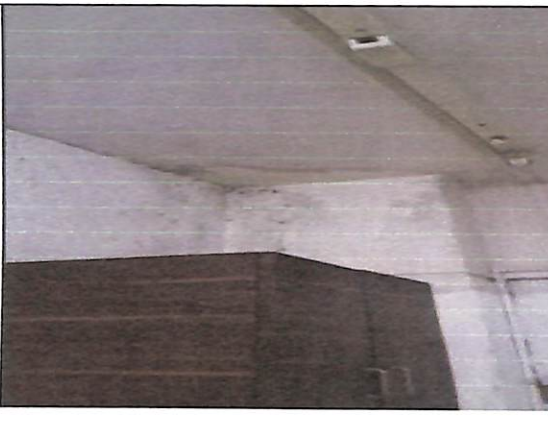
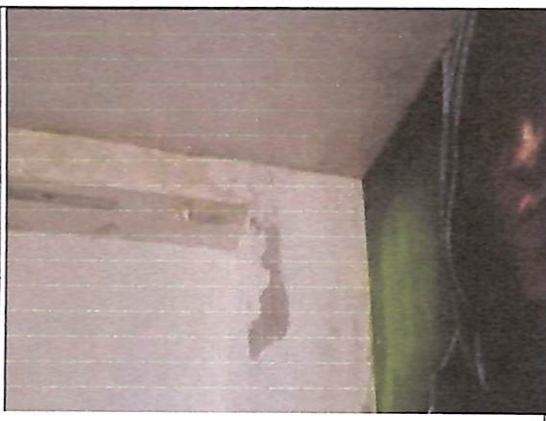
Location: – Auditorium Hall & GYM Khana	
Distress: — Leakage/seepage is noted on the ceiling & wall.

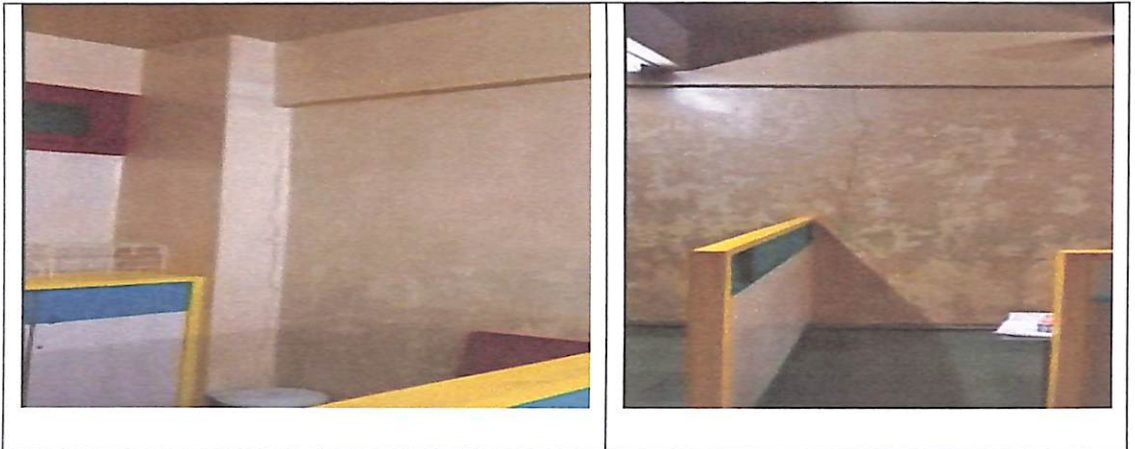
Location: – Class Room No. 1 (1st Floor)

Distress: — Cracks are noted on the column due to corrosion. Also, a diagonal crack is noted in the wall.

- Repairs like polymer/epoxy/micro concrete treatment are to be carried out at the locations where corrosion cracks, spalling of concrete and exposed reinforcement are observed after carrying out corrosion treatment.
- Low viscous epoxy/cement grouting is to be provided to the slabs to overcome the voids, honey combing and leakage related issues.
- As the excessive cracking is noted on the beams, the beams are to be grouted with low viscous epoxy grout.
- Crack Filling in the brick wall to be done by cement grout.
- 2 coats of 100% paint are to be applied internally over one coat of primer after preparing the surface properly.

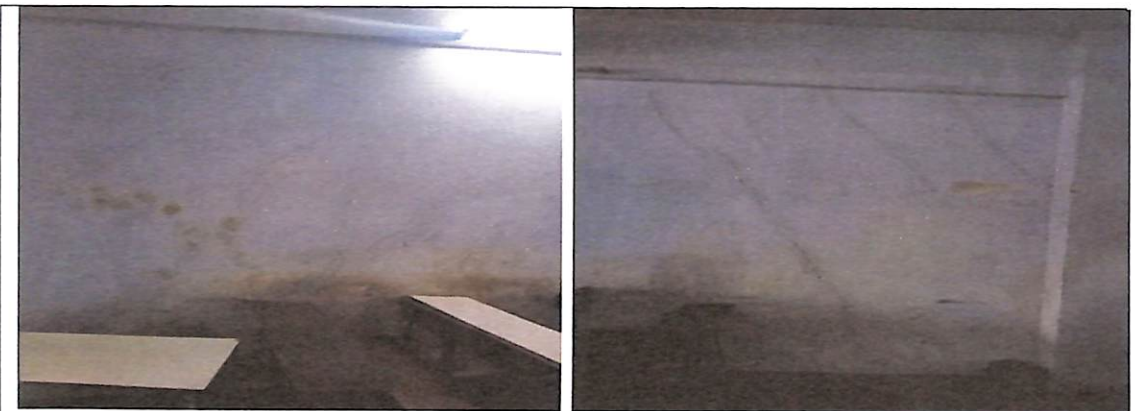
Location: – Class Room No. 4 (2nd Floor)

Distress: — A diagonal crack is noted on the wall.

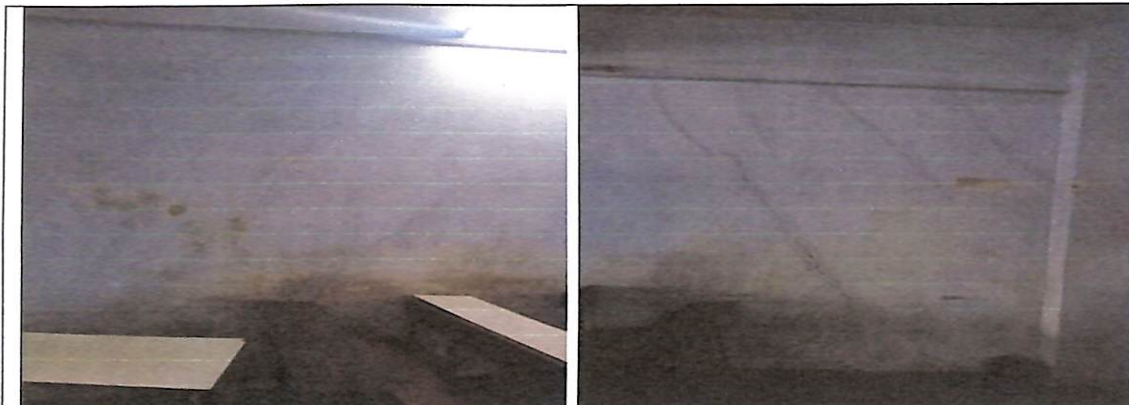
Location: – Class Room No. 4 (2nd Floor)

Distress: — A through diagonal crack is noted on the wall.

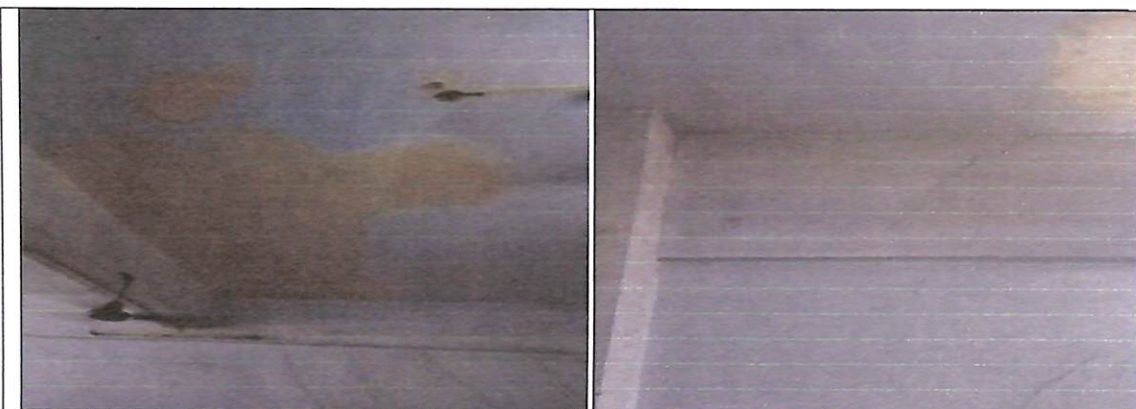
Location: – Class Room No. 205 (2nd Floor)

Distress: — Patch repair work is noted on the ceiling & a diagonal crack is noted on the beam.

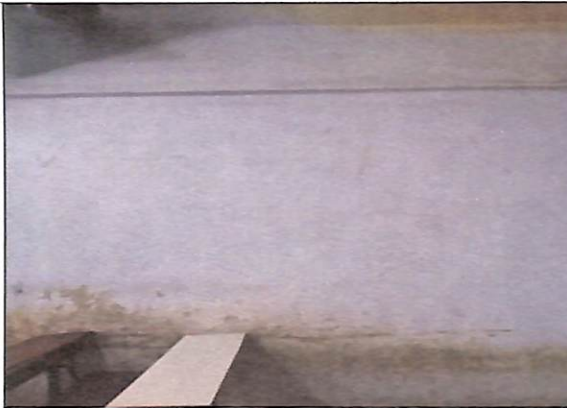
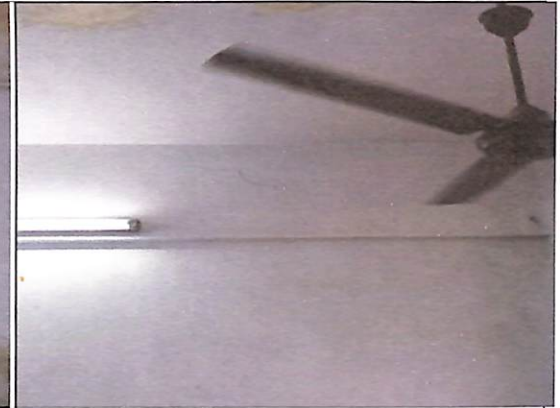
Location: – Class Room No. 201 (2 nd Floor)	
Distress: — A diagonal crack is noted on the beam.

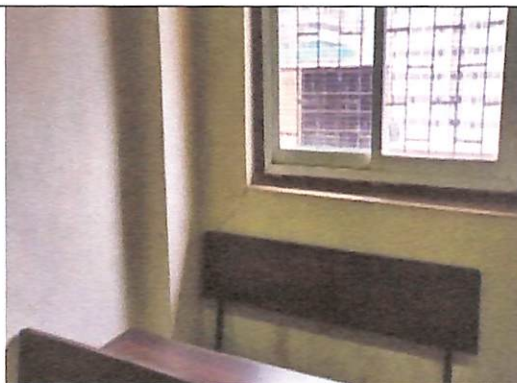
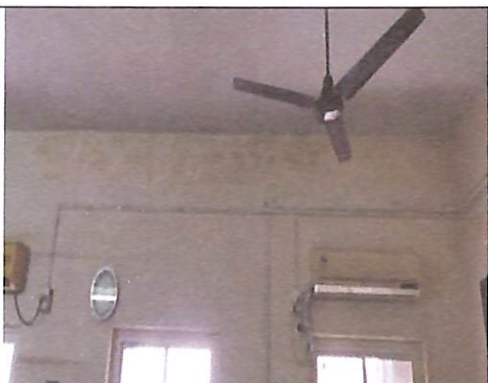
Location: – Room no.502	Location: - Room no.503
Distress: – A crack is noted in the masonry wall.	Distress: Leakage/Seepage marks are noted on the slab.

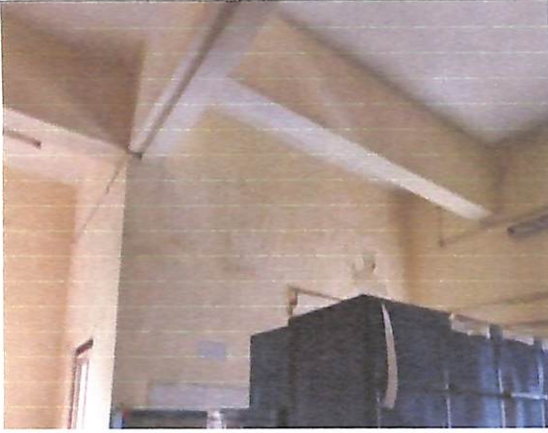
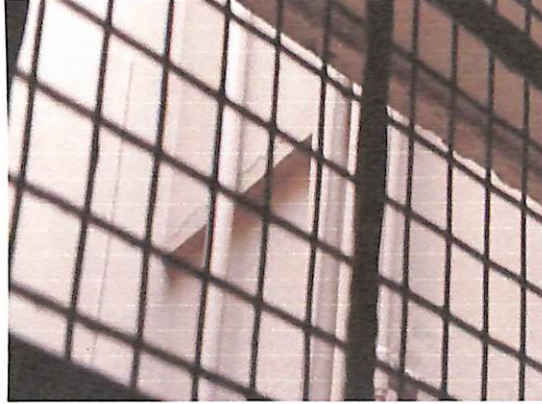
Location: – Room No.504	Location: - Dusk Side Beam.
Distress: – Leakage/Seepage marks are noted on the wall.	Distress: Cracks are noted on the beam bottom due to corrosion of reinforcement.

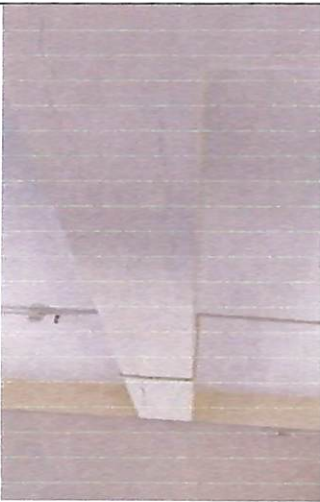
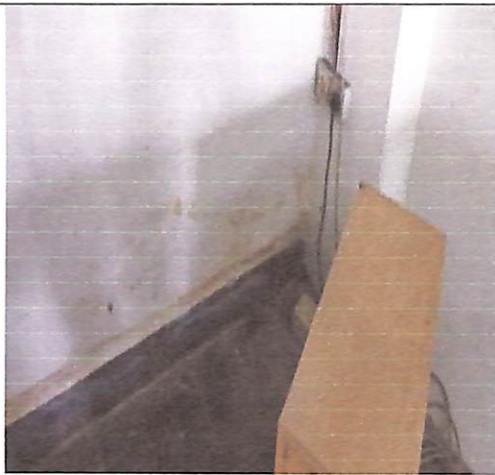
Location: – Room No.505	Location: -
Distress: – Cracks are noted on the beam bottom due to corrosion of reinforcement.	Distress: Leakage marks are seen on the passage side wall.

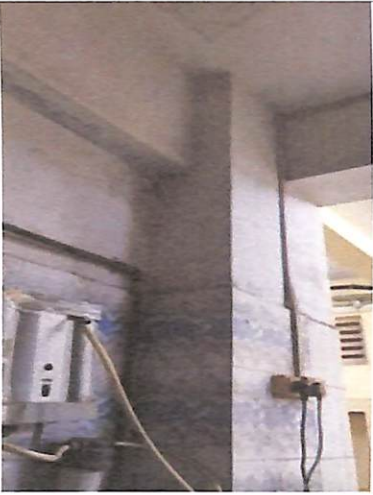
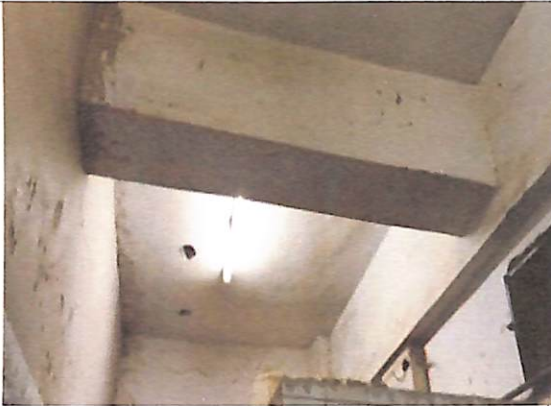
Location: – Fifth Floor Toilet Area	Location: -Toilet area
Distress: – Cracks are noted on the column due to corrosion of reinforcement.	Distress: Cracks are noted on the beam bottom due to corrosion of reinforcement.

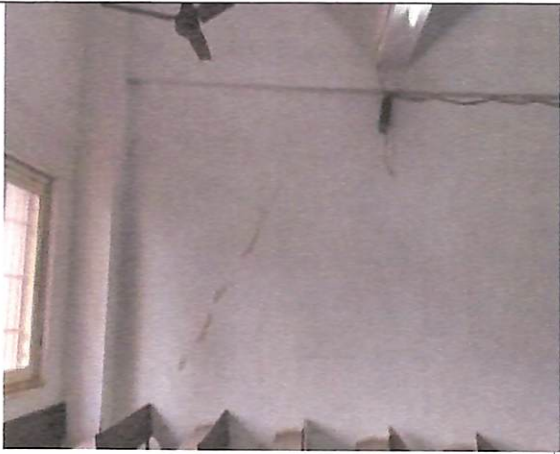
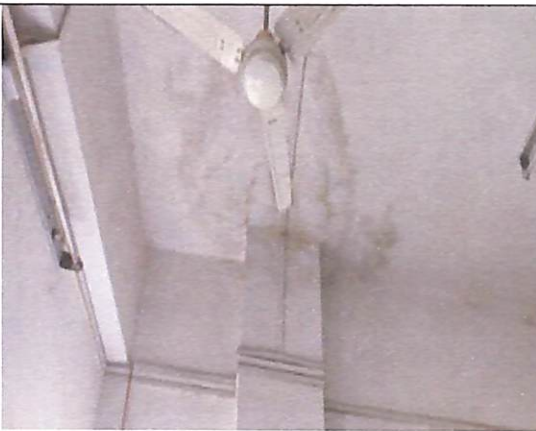
Location: – Room No .502	Location: - Room No .501
Distress: – A diagonal crack is noted on the masonry wall.	Distress: Leakage/Seepage marks are noted on the slab.

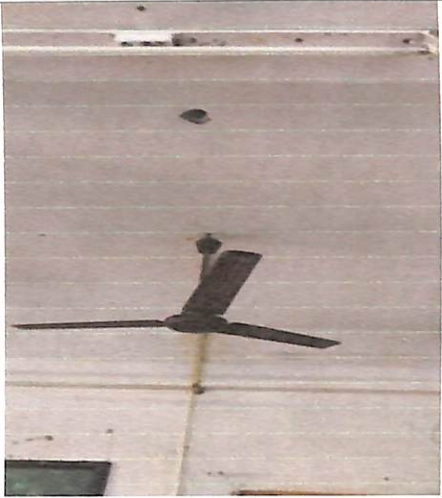
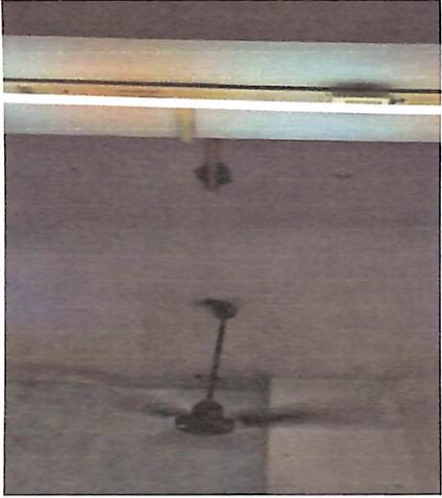
Location: – Room No.508	
Distress: – Cracks are noted on the slab due to corrosion of reinforcement.

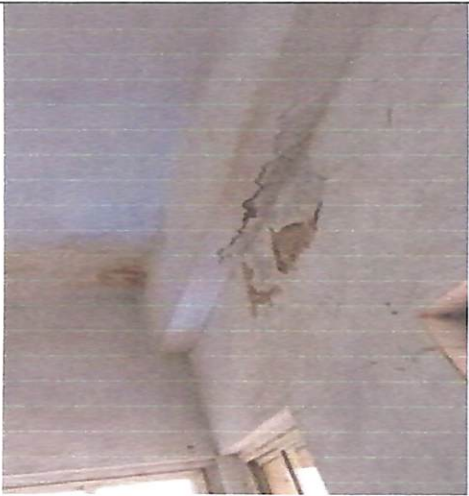
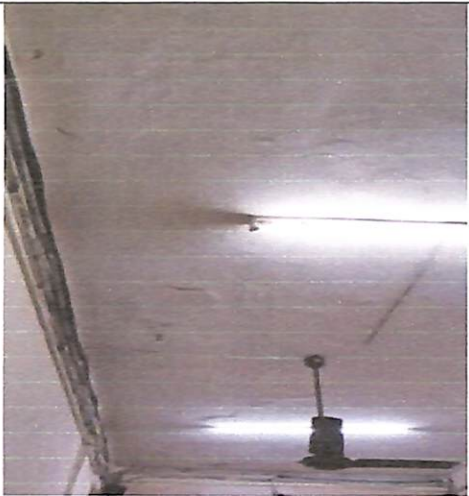
Location: – Room No.508	Location: - Room No. Passages area
Distress: – Cracks are noted on the beam bottom due to corrosion of reinforcement.	Distress: Bulging of cover concrete is noted on the slab.

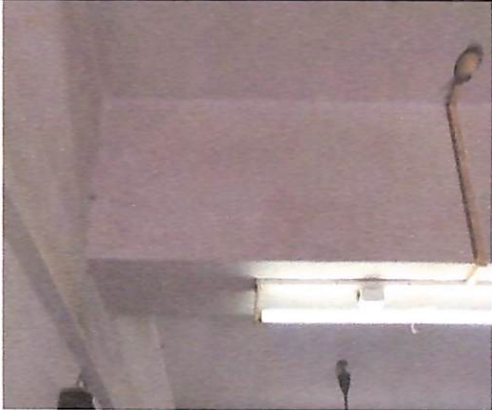
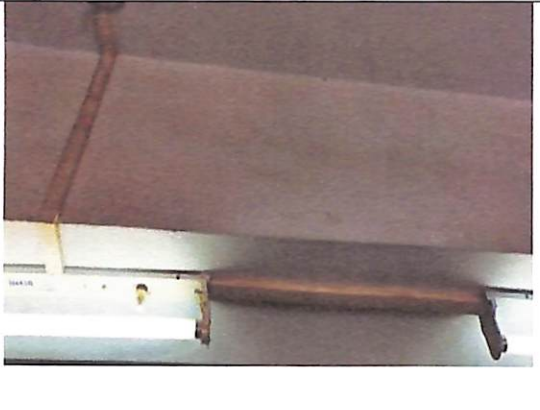
Location: – Room No.404	Location: - Room No.404
Distress: – A diagonal crack is noted on the beam.

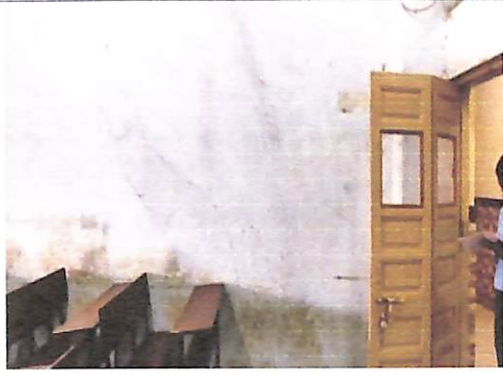
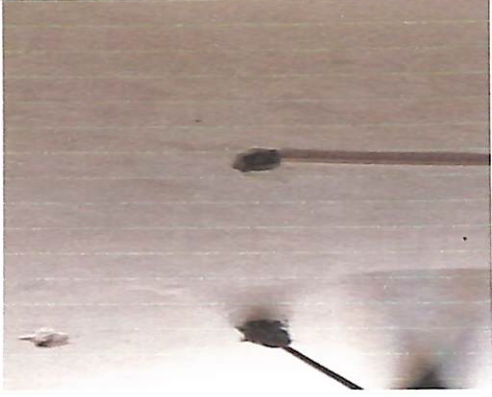
Location: – Room No.	Location: - Gyan sagar
Distress: – A diagonal crack is noted on the masonry wall.	Distress: Cracks are noted on the slab due to corrosion of reinforcement.

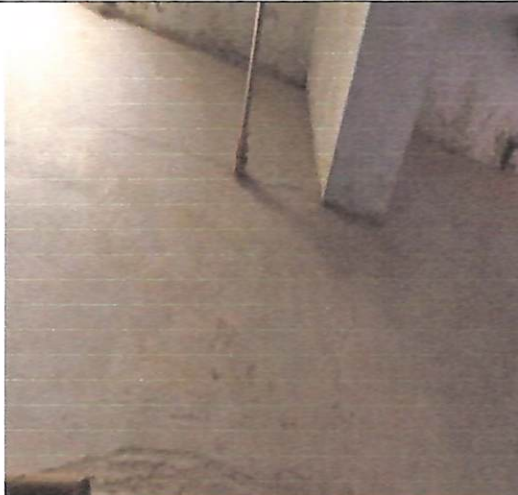
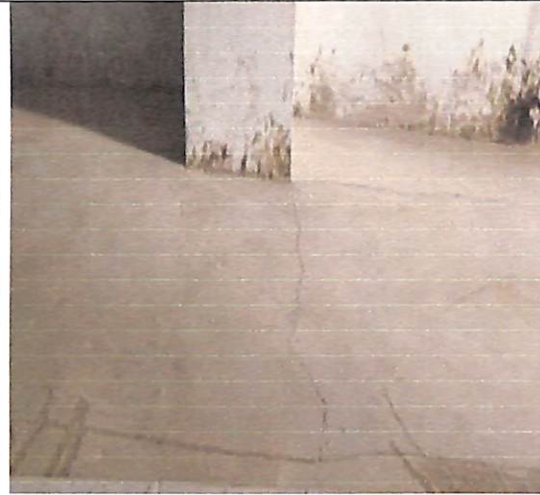
Location: - Fourth Floor Ladies wash Room	
Distress: Vertical and horizontal cracks are seen on the masonry wall.

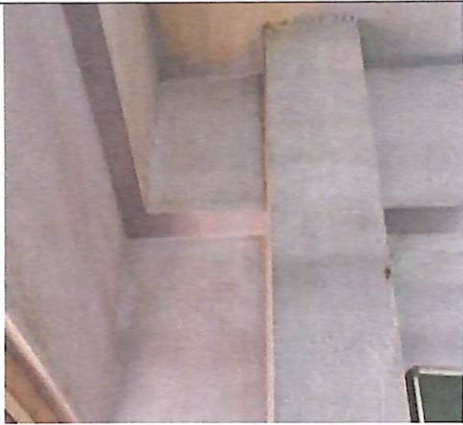
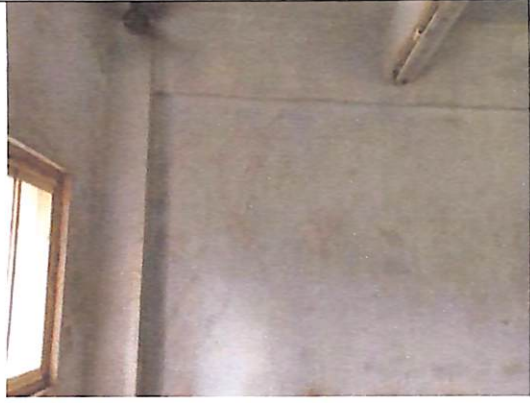
Location: – Room No.308	Location: - Room No.301
Distress: – A diagonal crack is noted on the masonry wall.

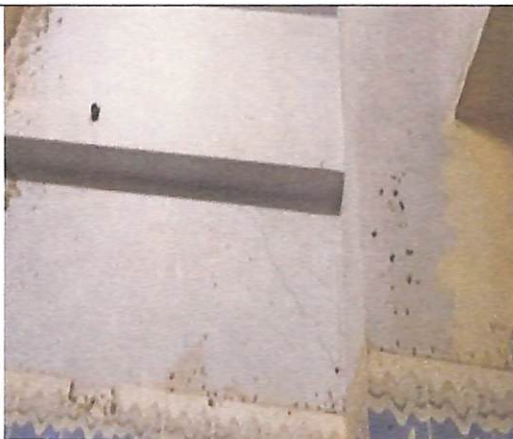
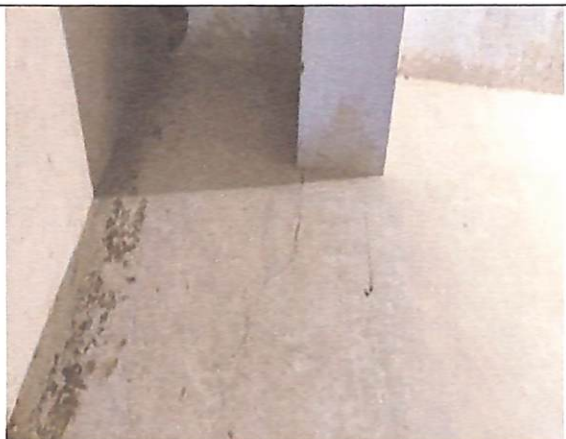
Location: – Third Floor Toilet	Location: – Third Floor Toilet
Distress: — A diagonal crack is noted on the masonry wall.	Distress: — A vertical crack is noted on the masonry wall.

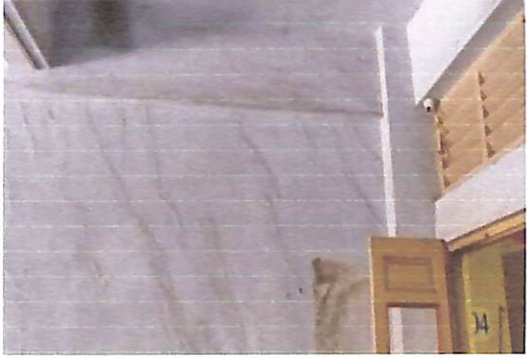
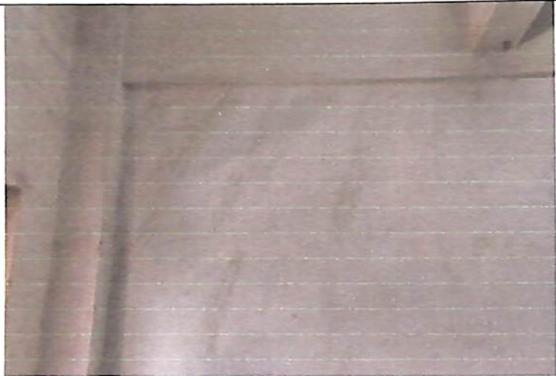
Location: – Room No.304	
Distress: — A diagonal crack is noted on the masonry wall.

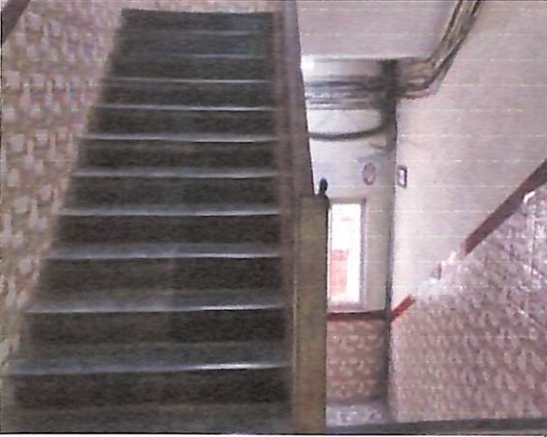
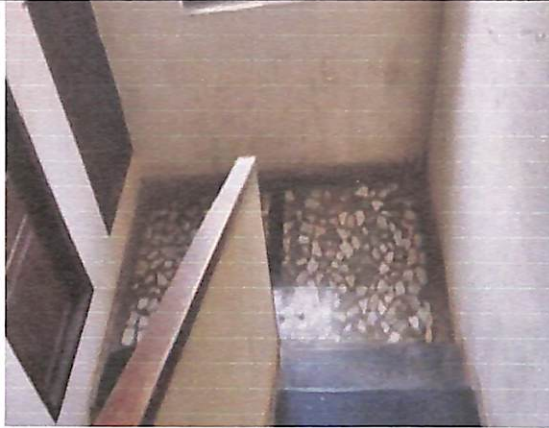
Location: – Staircase area	
Distress: — No distress observed.

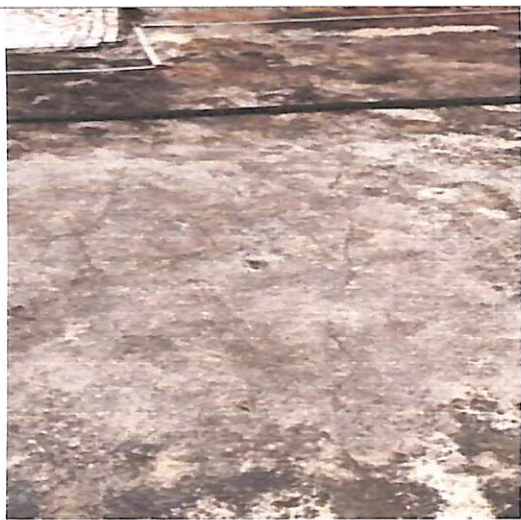
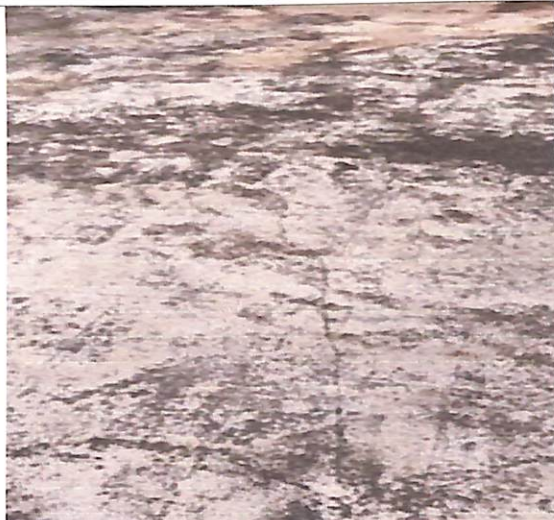
Location- Terrace	Location- Terrace
Distress: – Cracks are noted in the IPS waterproofing.

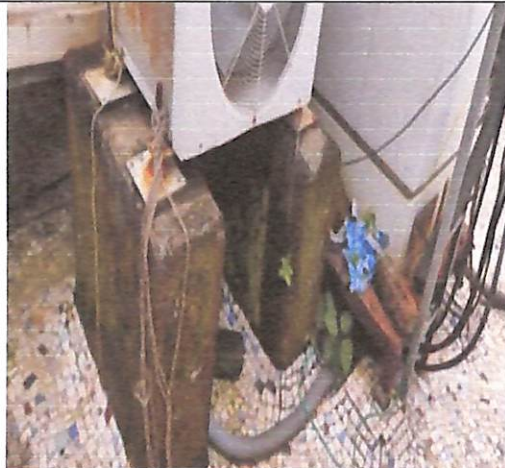
Location: – Terrace
Distress: – Vegetation and moss growth is noted on the pedestal.

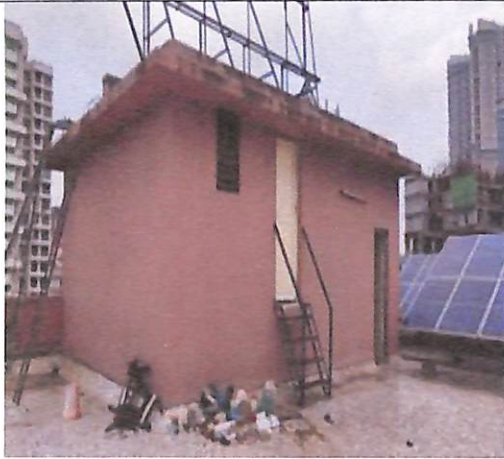
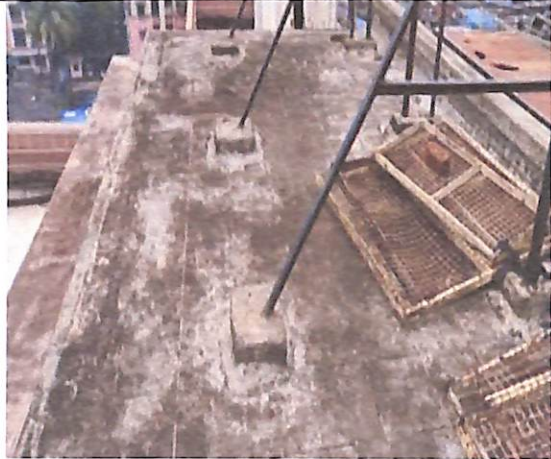
Location: – North Side Headroom	Location: – North Side Headroom
Distress: – View	Distress: Fine cracks are noted in the IPS Flooring.

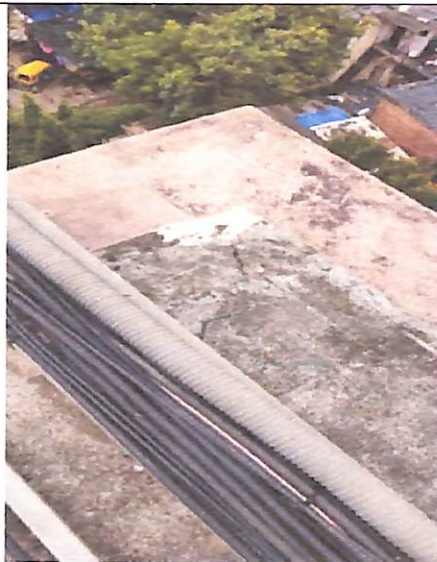
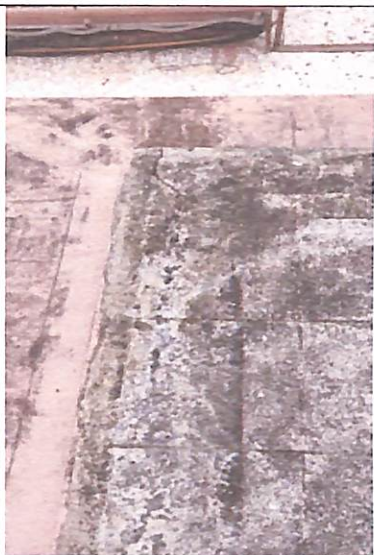
Location: – North Side Headroom	Location: – North Side Headroom
Distress: –Cracks are noted in the IPS Flooring.

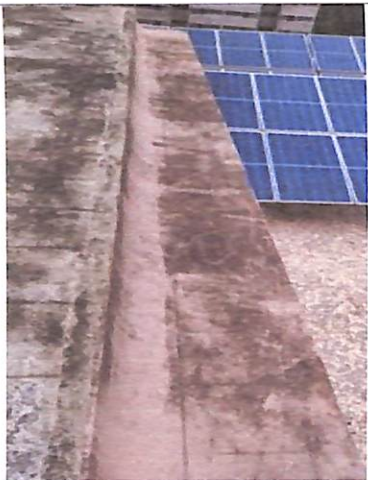
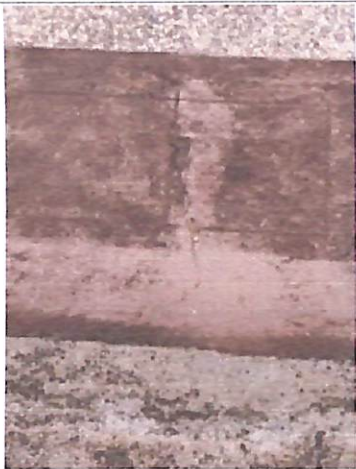
Location: – North Side Headroom	Location: – North Side Headroom
Distress: – Cracks are noted in the IPS Flooring.

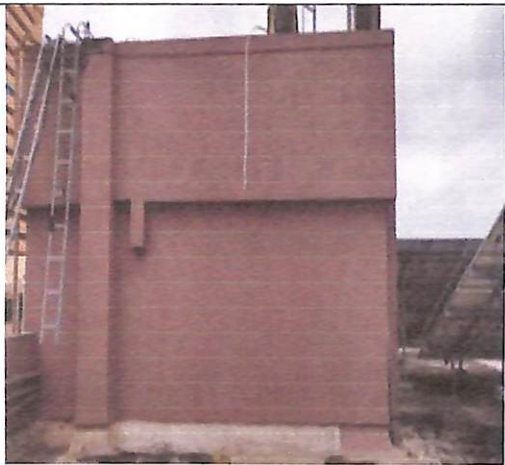
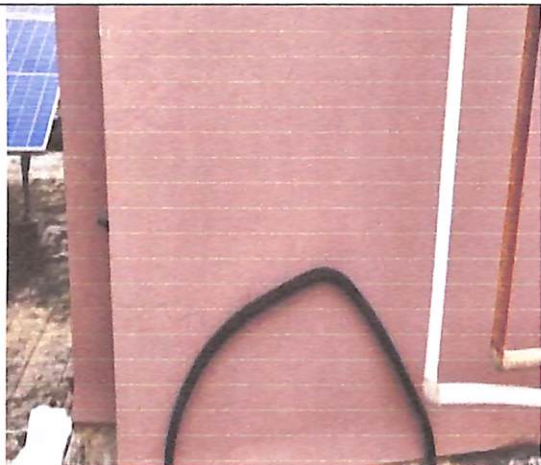
Location: – OHWT	Location: – OHWT
Distress: – Cracks are seen in the plaster of the external wall.

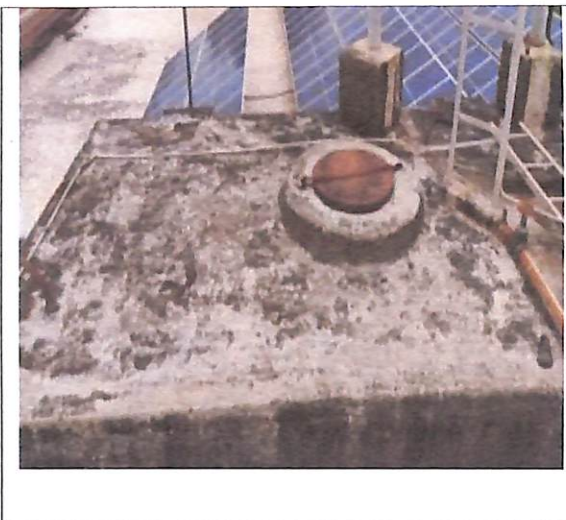
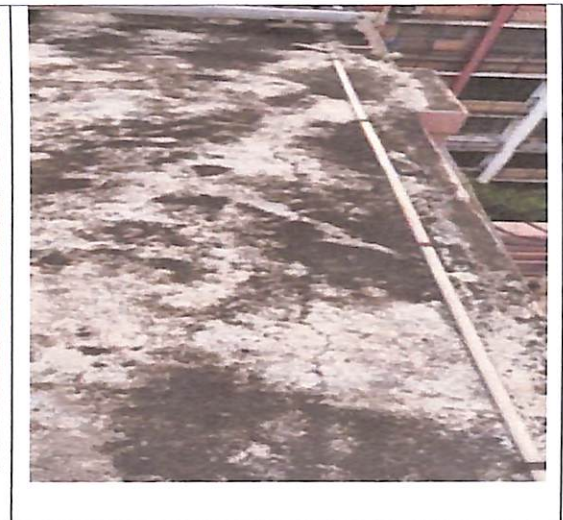
Location: – Top surface	
Distress: – Cracks are seen in the top surface.	Distress: Cracks are seen in the top surface.
