Structural Audit Report
of
“K.G Mittal College, Malad (West) Mumbai

SEPTEMBER - 2020

**STRUCTWEL DESIGNERS &
CONSULTANTS PVT. LTD.**

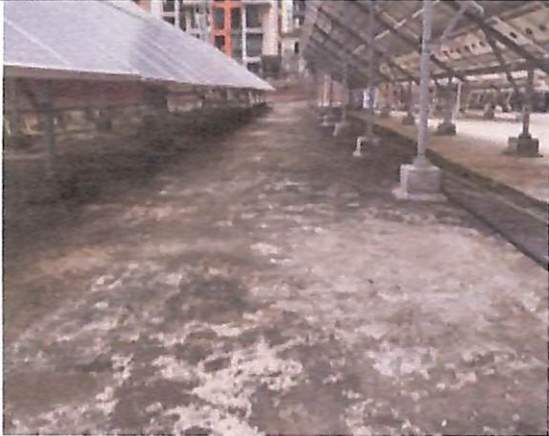
- Cracks are seen in the IPS waterproofing.
- Vegetation and moss growth is seen on the pedestal.
- Fine cracks are noted in the IPS Flooring of the Headroom.
- Cracks are seen in the plaster on the North side Headroom and OHWT External wall.
- Cracks are seen in the IPS Flooring and in the top Slab of OHWT.

Location- Terrace	Location- Terrace
Distress: – View of the Terrace Part of IPS	Distress: View of the Terrace Part of China Chips
